## INVESTIGATION OF FAILURE OF DOUBLE SUSPENSION SPRING OF RAILWAY COACH

### Abstract

Shock absorber spring is important component in fiat bogie of coach of Indian railways. Nested springs are used in double suspension system of fiat bogie. The most common problem of the failure of suspension system is the failure of springs during service. When a spring fails in a suspension system in a Fiat Bogie there are a number of mishaps which can happen like accidents, discomfort, loss of life these are some of the extreme happenings. The frequent failure of spring also results in valuable man hour wastage in maintenance and replacement of it. In this paper the causes responsible for the spring is studied and the failure analysis of it is presented. The study reveals major reasons of the failure of spring- failure due to reduction in the permissible free height, fretting, stress corrosion and rubbing marks. The study is carried out in the period of March 2019 and total 144 defects were reported. The paper also presents the metallurgical analysis of the bogie spring.

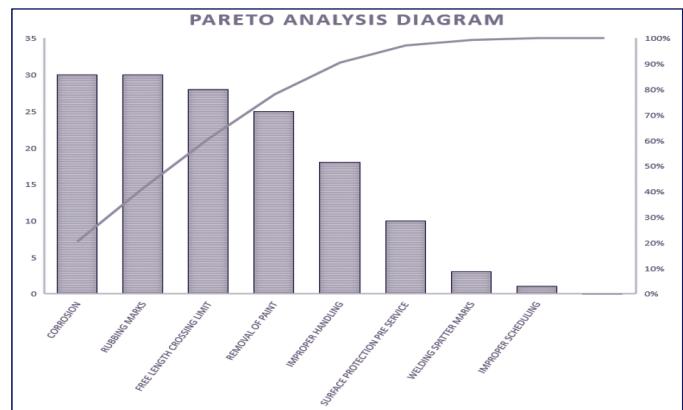
**Figure 3: Pareto analysis for March 2019**

No.	Type of defects	Total number of defects	Defects percent
1	Corrosion	30	20.83
2	Rubbing Marks	30	20.83
3	Free length crossing limit	28	19.44
4	Removal of paint	25	17.36
5	Improper handling	18	12.5
6	Surface coating pre service	9	6.25
7	Welding spatter marks	3	2.08
8	Improper scheduling	1	0.60
	Total	144

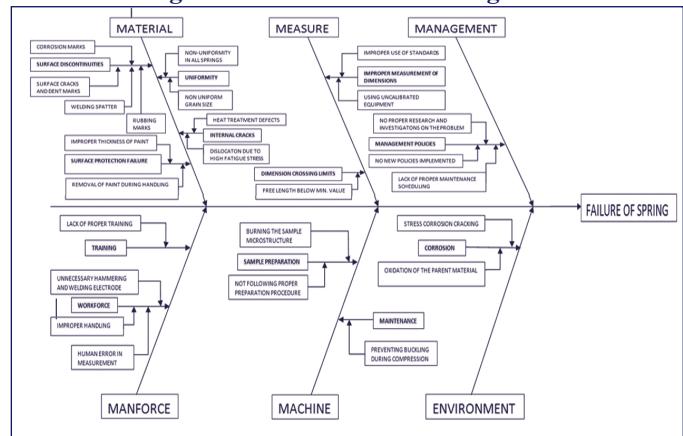
**Figure 4: Cause and effect diagram**

**Failure Investigation:** The investigation is started first with collection of data for failure of spring over a fixed period of time. . The characteristics of various defects specifically raw material defect, manufacturing defect, improper service condition, environmental defects, surface imperfection etc. are considered in the study. So considering their way towards finding the cause of failure of spring as a primary step of research on the root cause finding on failure of spring is to have an actual visual inspection of the failure surface for effective observation the visual observation must be done immediately after the occurrence of failure. Visual inspection include all the possible observations seen during the inspection of the springs and noting the observation along with the comments about their appearance, nature, colour, any surface irregularity etc. seen near the surface of failure. The cause effect diagram and Pareto analysis is prepared for finding all the possible causes for failure and the finding which failure is contributing the maximum times. The collection of data for the Pareto analysis includes frequencies of number of springs that fail due to several reasons. Twenty seven 27 spring were observed which failed due to reductions in free height. 10 nos. of springs that were observed and was found that there is the removal of paint at some spots and these springs were observed immediately when bought from manufacturer to workshop. This means that there is mishandling during the shipment of springs from manufacturer.30 nos. of fractured springs were observed and out of the 30 number of fractured springs all springs were found to have corrosion mark and rubbing marks. 25 nos. of spring had paint removal on the bearing coil where fracture took place.18 springs were found to have scratch marks on the outer surface of active coil. 3 number of spring had welding spatter marks and 1nos. (approx.) of spring were failed and not even replaced due to urgent requirement and this means that there is improper scheduling of maintenance. The table 1 shows the defect analysis carried out in March 2019. The parato diagram is prepared based on the table 1 as shown in figure 3. The cause and effect diagram is prepared considering the 6 major causes of defects which are the main branches, each having various root causes which form sub branches as shown in figure 4.

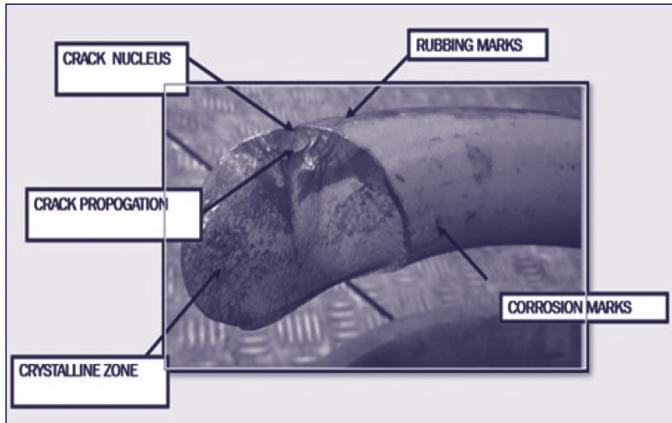
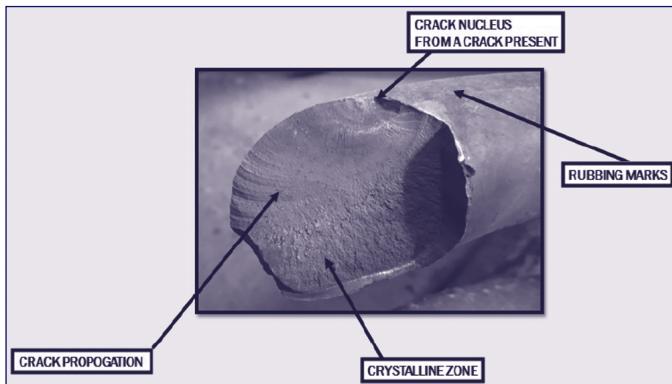
**Figure 5: Failed Primary Inner Spring of LHB Bogie Suspension**

**Figure 6: Failed Primary Inner Spring of LHB Bogie Suspension**

In the above photograph figure 5 and 6, different factors found on the failed surface can be clearly seen. The failure of the inner spring has taken place in the first active coil of the spring. The failure is progressive and covers roughly 20-25% of the cross section area. The rest of the fracture region is observed to be crystalline in nature. Noticing further the crack nucleus is situated on the upper surface closer to the visible rubbing marks. The propagation of the crack can be vividly seen near the upper surface propagating towards the centre.

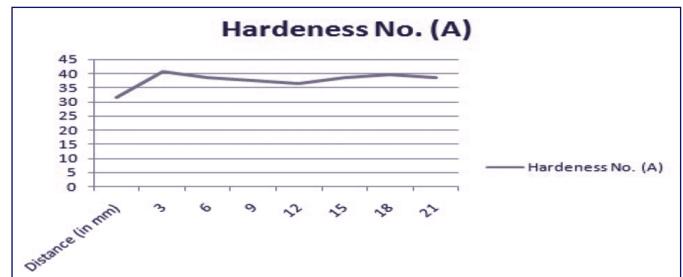
**Figure 7: Hardness Test Results for a Primary Inner Spring A**

**Destructive Test In Failure Analysis:** Hardness test is the most common test conducted on a small fractured sample for evaluating heat treatment, this is followed by estimation of ultimate tensile strength and determination of the extent of work hardening or decarburization which has occurred on the fractured component during the service period, if there is any such proof. Since it is difficult to find large amount of material of the failed components for tensile and fatigue tests, failure analysts mostly rely on hardness tests. Hence it is for this reason that hardness test is conducted on the primary inner spring. The Rockwell hardness test results are shown in figure 7 and 8.

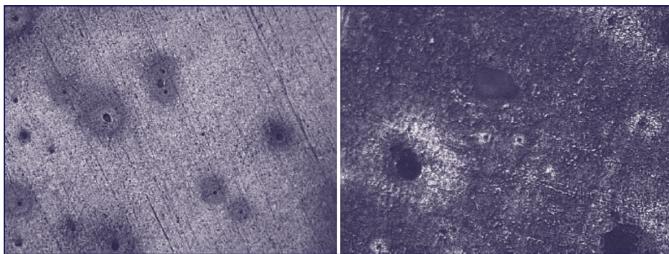
**Figure 9: Spring Microstructure**

**Microscopic Examination Of Fracture Surfaces:** The observation of spring microstructure shows (figure 9) the presence of pitting marks due to stress corrosion.

- The microstructural image reveals that the material is tempered martensite. The microstructure was found with deep pitting marks.
- The broken springs were found with rubbing mark due to fretting,
- The broken spring sample was found with rough and wavy surface
- Poor shot peening action on the inner surface due to less space issues can be the reason of less compressive stresses, because of which crack initiated starts propagating with speed and fractures the coil mostly from the inner surface of the spring coil,
- The new spring arrived from manufacturer was found with paint removal marks and the corrosion marks, removal of paint can be the reason for corrosion which causes Stress Corrosion Cracking.

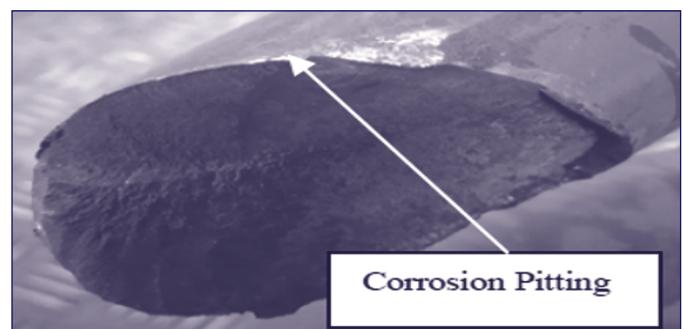
**Figure 10: Corrosion Pitting Sample**

The broken springs were found with rubbing mark due to fretting. Taking fretting into consideration, the spring base material must not come in contact with the water (moisture) or water particles or oxidizing environment.

The maintenance of any bogie part must be done free from water so as to avoid corrosion of the spring.

From the statistics collected from the maintenance workshop around 33 springs of non AC coaches failed in the year 2018 out of which 8 springs were from the trains running between Solapur to Kolhapur and Siddheshwar Exp. Therefore, the need arises to find out the root causes contributing to the failure of the spring, so it suggested to maintain the track terrain and also to clean the spring surface using dry air jet so as to avoid the pitting corrosion of the surface.

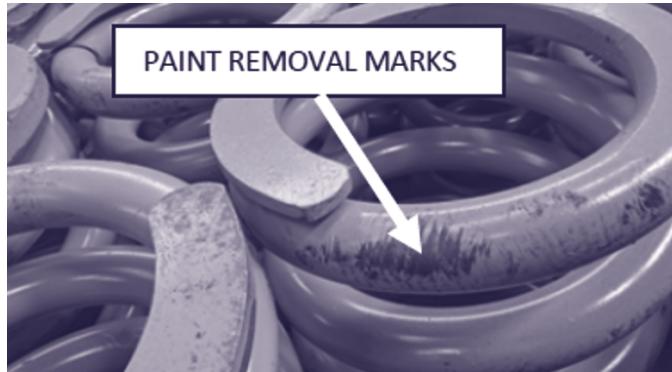
The new spring arrived from manufacturer was found with paint removal marks and the corrosion marks. Hence removal of paint can be the reason for corrosion which causes Stress Corrosion Cracking. It is recommended to properly paint the springs and handle the spring properly during shipment so that the spring doesn't get damaged during the transportation. It is also recommended to use material handling devices to handling the spring during maintenance.

**Figure 11: Paint removal sample**

For avoiding the corrosion of springs, it is suggested to apply red oxide paint on the metal portion and then allow the red oxide paint to dry, after that the paint must be applied on new spring so that when paint is removed the base metal doesn't comes in direct contact with environment.

The paint on the springs was irregular and it is suggested to use spray pumps to paint the spring so as to maintain the uniform thickness of the paint throughout.

Before applying the paint on spring or any other part, the previous paint must be removed and after that cleaned using high pressure air jet instead of manual cleaning and be made dust free. After that red oxide paint must be applied and paint properly adheres to the metal surface avoiding metal to environment contact. red oxide is applied so as to avoid the contact of base metal and environment if paint is removed during service condition.
